Home Buyer:

Property Address:

As follows is a complete inspection done by Pedro Diaz of Broward Inspect LLC. This is a visual inspection and as such has its limitations. Please READ CAREFULLY the disclosures page as it outlines this inspection's limitations as well as its scope. Thank you for choosing Broward Inspect LLC. I look forward to serving you presently and in the future with all your Home Inspection needs.

SUMMARY OF FINDINGS.....	6
STRUCTURE INSPECTION REPORT	8
GROUNDS/POOL INSPECTION REPORT	9
ROOF INSPECTION REPORT	10
KITCHEN AND APPLIANCES INSPECTION REPORT	11
PLUMBING/BATHROOM INSPECTION REPORT.....	12
INTERIOR INSPECTION REPORT	14
HEATING AND COOLING INSPECTION REPORT.....	15
WATER HEATER INSPECTION REPORT	16
ELECTRICAL INSPECTION REPORT	17

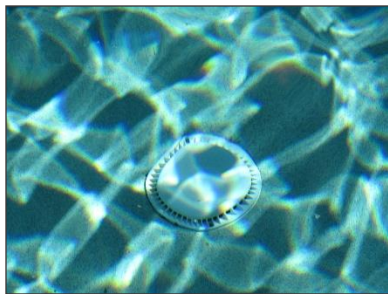
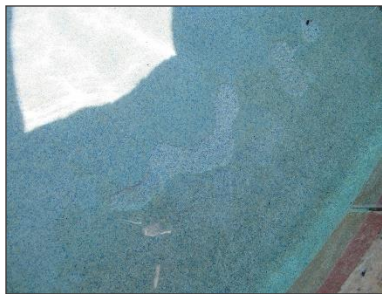
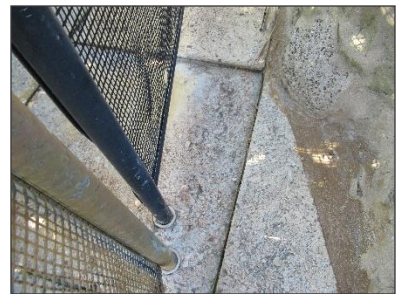
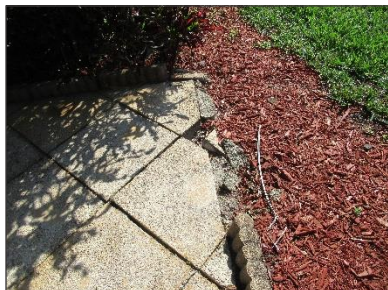
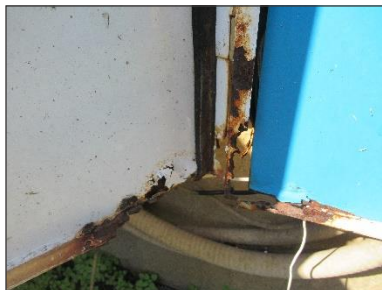
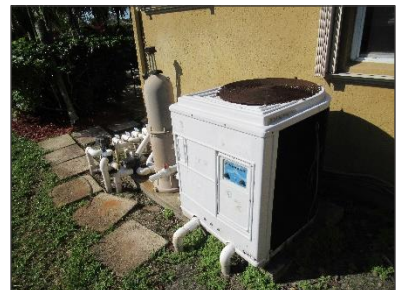
1. Pool drain not anti-vortex. Approximate cost for licensed professional to replace \$600+ (\$150 each x 4)
2. Pool coating deteriorated at several areas at steps
3. Pool deck pavers uneven behind east water feature
4. Rust noted at base of pool electrical panel
5. Owner indicated pool heater does not function

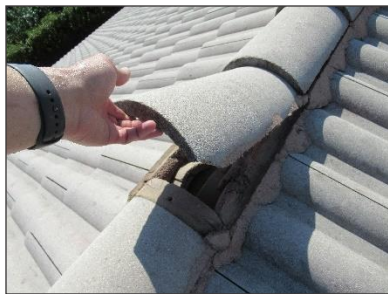
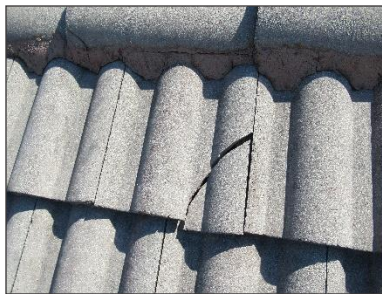
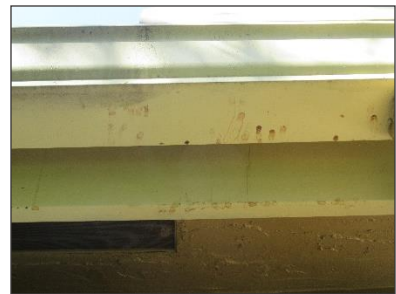
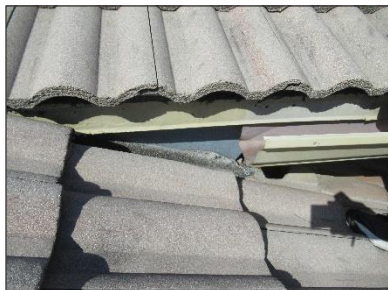
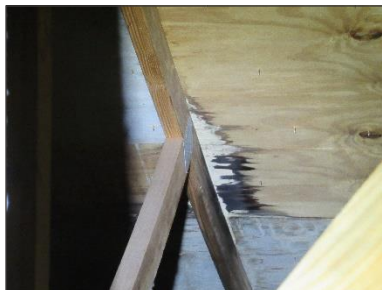
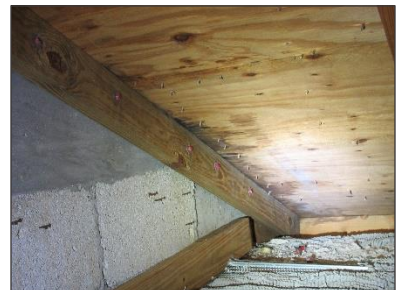
1. Roof inspection by Paletz Roofing. All comments are by Paletz Roofing
2. Fascia damage, previous repairs, sheathing damage, cracked and loose tiles
3. Roof is near end of useful life
4. Cost to repair noted deficiencies by Paletz Roofing \$3,495
5. Recommend getting 2 - 3 estimates from licensed roofing contractors
6. Refer to Paletz Roofing Inspection Report for full details

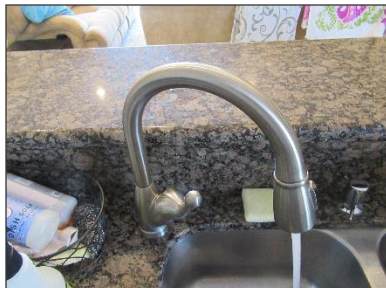
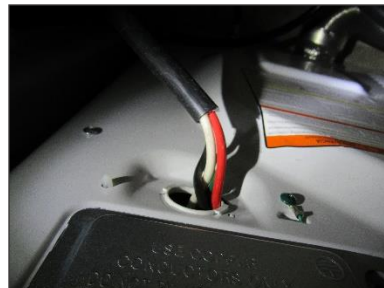
1. Hot/cold reversed at sink
2. Clothes dryer missing securing clamp at electrical cord entry to housing

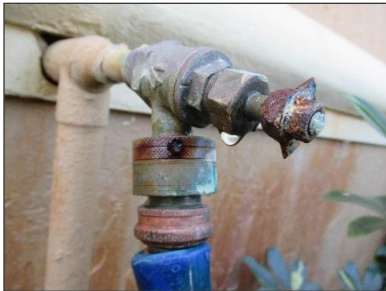
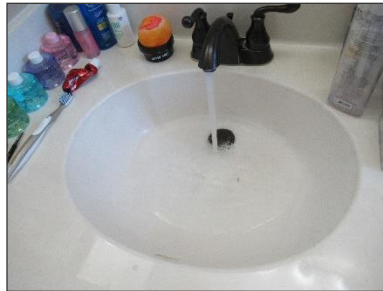
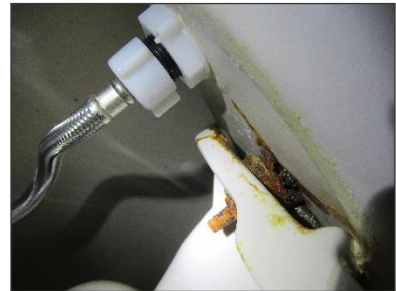
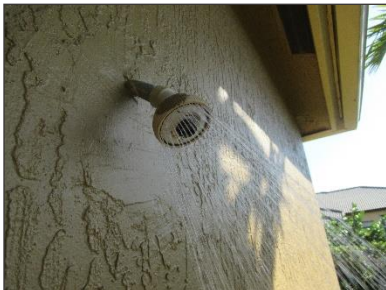
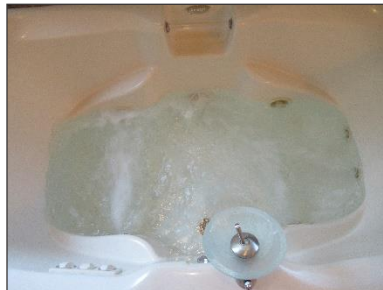
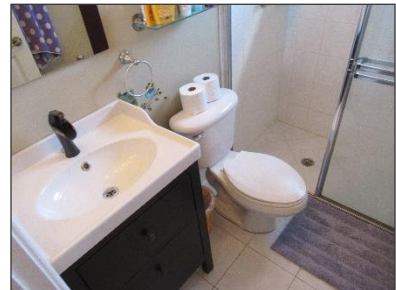
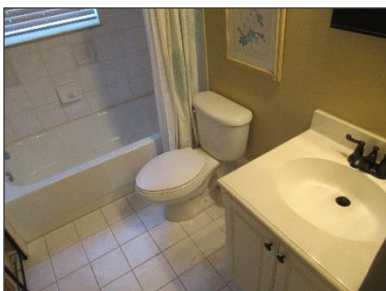
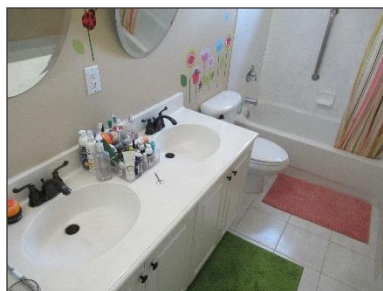
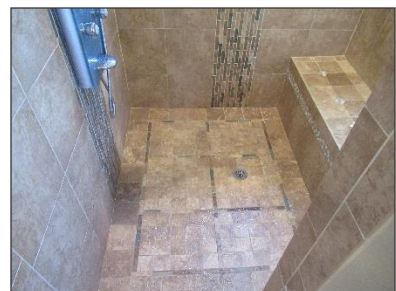
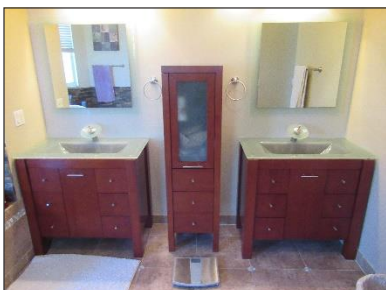
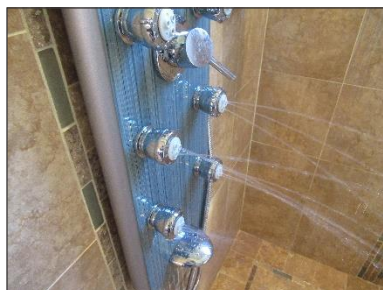
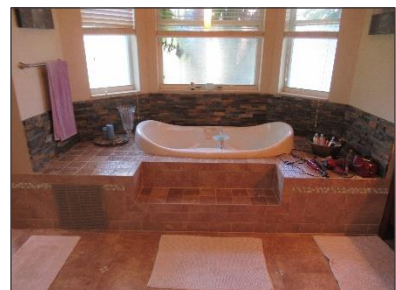
1. Leak noted at front hose bib
2. Bathroom #2: left sink slow to drain
3. Bathroom #1: leak noted at toilet (tank to bowl connection)
4. Approximate cost for licensed plumber to repair noted deficiencies \$350+

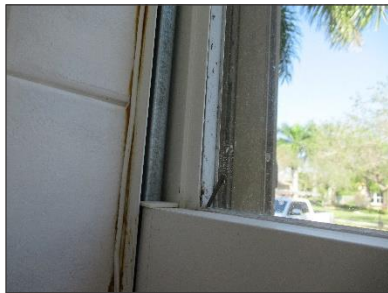
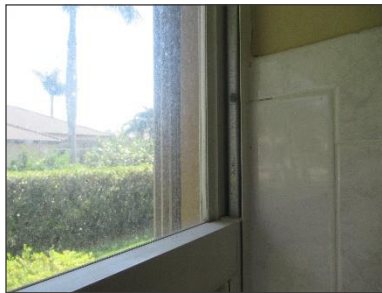
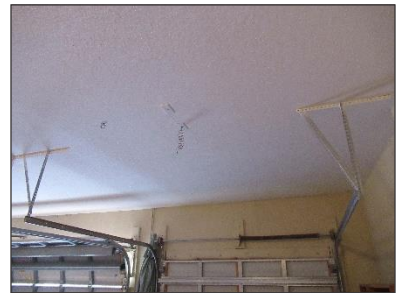
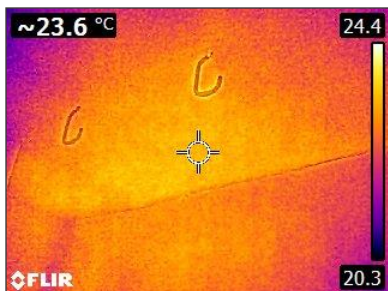
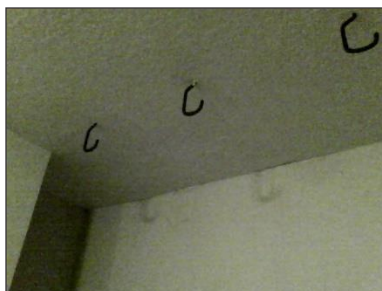
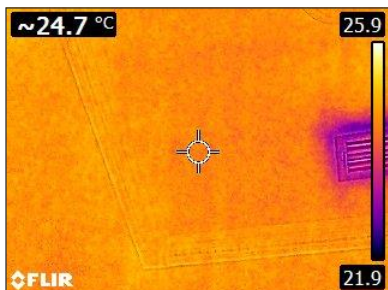
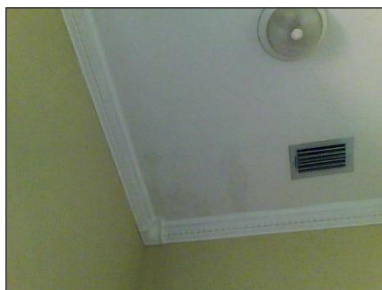
1. Window closing mechanism damaged at front bedroom and hall bathroom windows
2. Evidence of moisture noted at entry foyer and garage ceilings - dry at time of inspection
3. Missing single door garage door opener
4. Approximate cost for licensed professional to repair damaged closing mechanisms \$300+

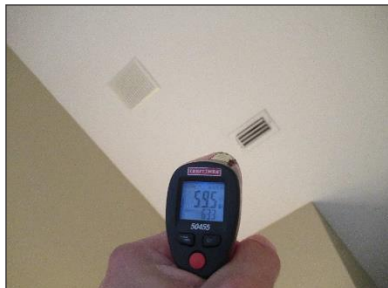
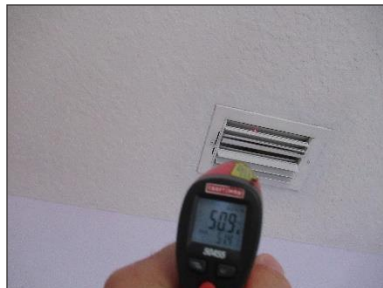
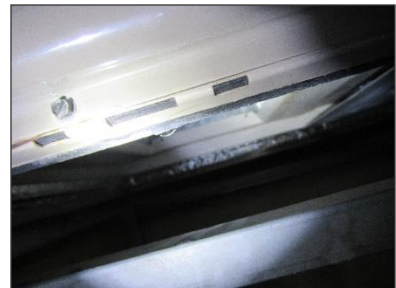
1. Both a/c systems are cooling satisfactory at time of inspection
2. Unit #2 air handler leaking water from below unit
3. Recommend servicing Unit #2 air handler

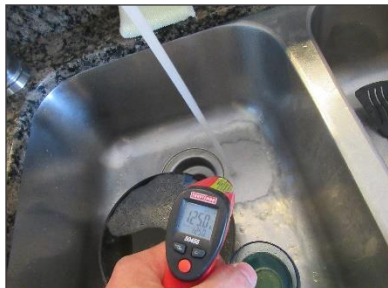
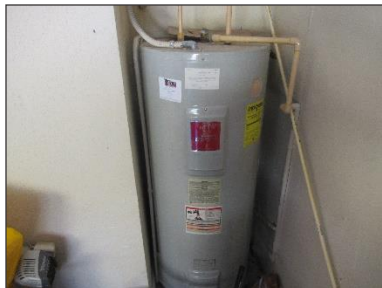
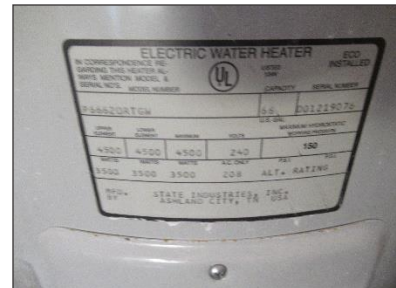
1. Water heater is heating satisfactory at time of inspection
2. Water heater is past its expected service life (current age 18 years)
3. Approximate cost to replace water heater by a licensed plumber \$850+

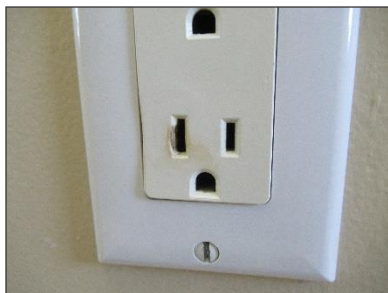
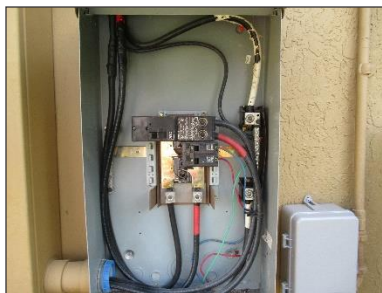
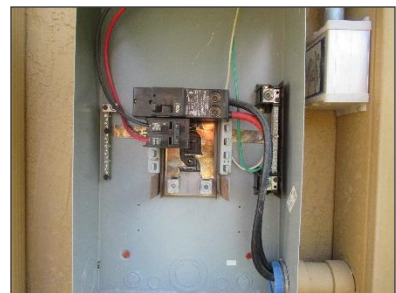
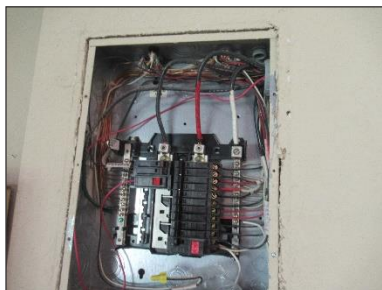
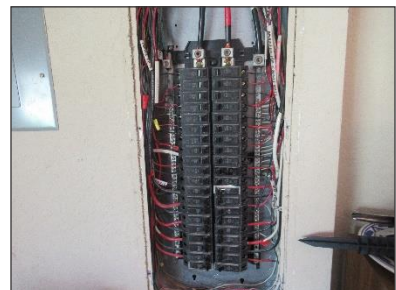
1. Evidence of short at hall bathroom outlet
