Home Buyer:

Property Address:

As follows is a complete inspection done by Pedro Diaz of Broward Inspect LLC. This is a visual inspection and as such has its limitations. Please READ CAREFULLY the disclosures page as it outlines this inspection's limitations as well as its scope. Thank you for choosing Broward Inspect LLC. I look forward to serving you presently and in the future with all your Home Inspection needs.

SUMMARY OF FINDINGS.....	6
STRUCTURE INSPECTION REPORT	8
GROUNDS/POOL INSPECTION REPORT	9
ROOF INSPECTION REPORT	10
KITCHEN AND APPLIANCES INSPECTION REPORT	11
PLUMBING/BATHROOM INSPECTION REPORT.....	12
INTERIOR INSPECTION REPORT	14
HEATING AND COOLING INSPECTION REPORT.....	15
WATER HEATER INSPECTION REPORT	16
ELECTRICAL INSPECTION REPORT	17

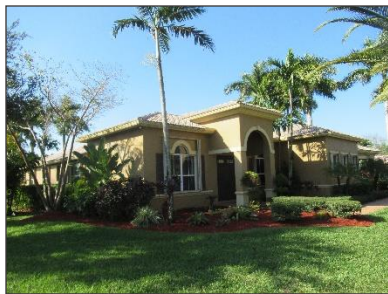
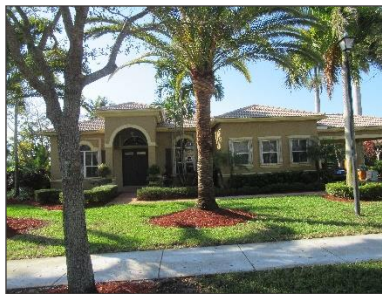
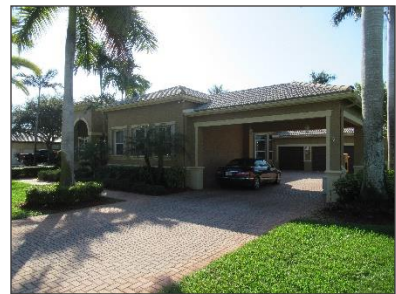
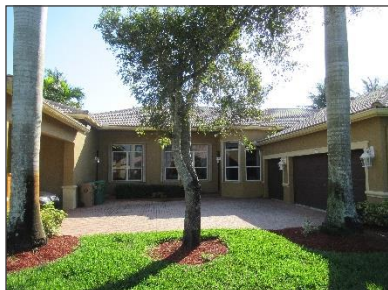
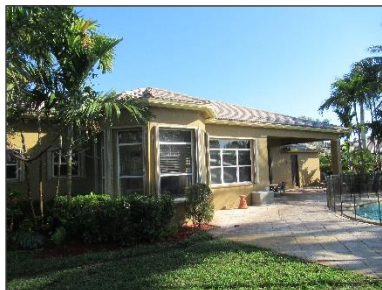
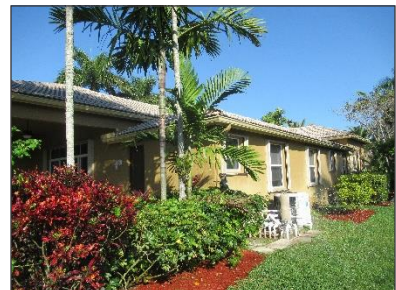
STRUCTURE INSPECTION REPORT

1. Roof inspection by Paletz Roofing. All comments are by Paletz Roofing
2. Fascia damage, previous repairs, sheathing damage, cracked and loose tiles
3. Roof is near end of useful life
4. Cost to repair noted deficiencies by Paletz Roofing \$3,495
5. Recommend getting 2 - 3 estimates from licensed roofing contractors
6. Refer to Paletz Roofing Inspection Report for full details
